**E6534.01-113-11-R0**  
**ACOUSTICAL PERFORMANCE TEST REPORT**  
**ASTM E 90, ASTM E 492, ASTM E 2179**

**ECORE INTERNATIONAL**

**Series/Model: 25.4 mm UltraTile® on Concrete Slab**

**Specimen Type: Concrete Slab - 152 mm**

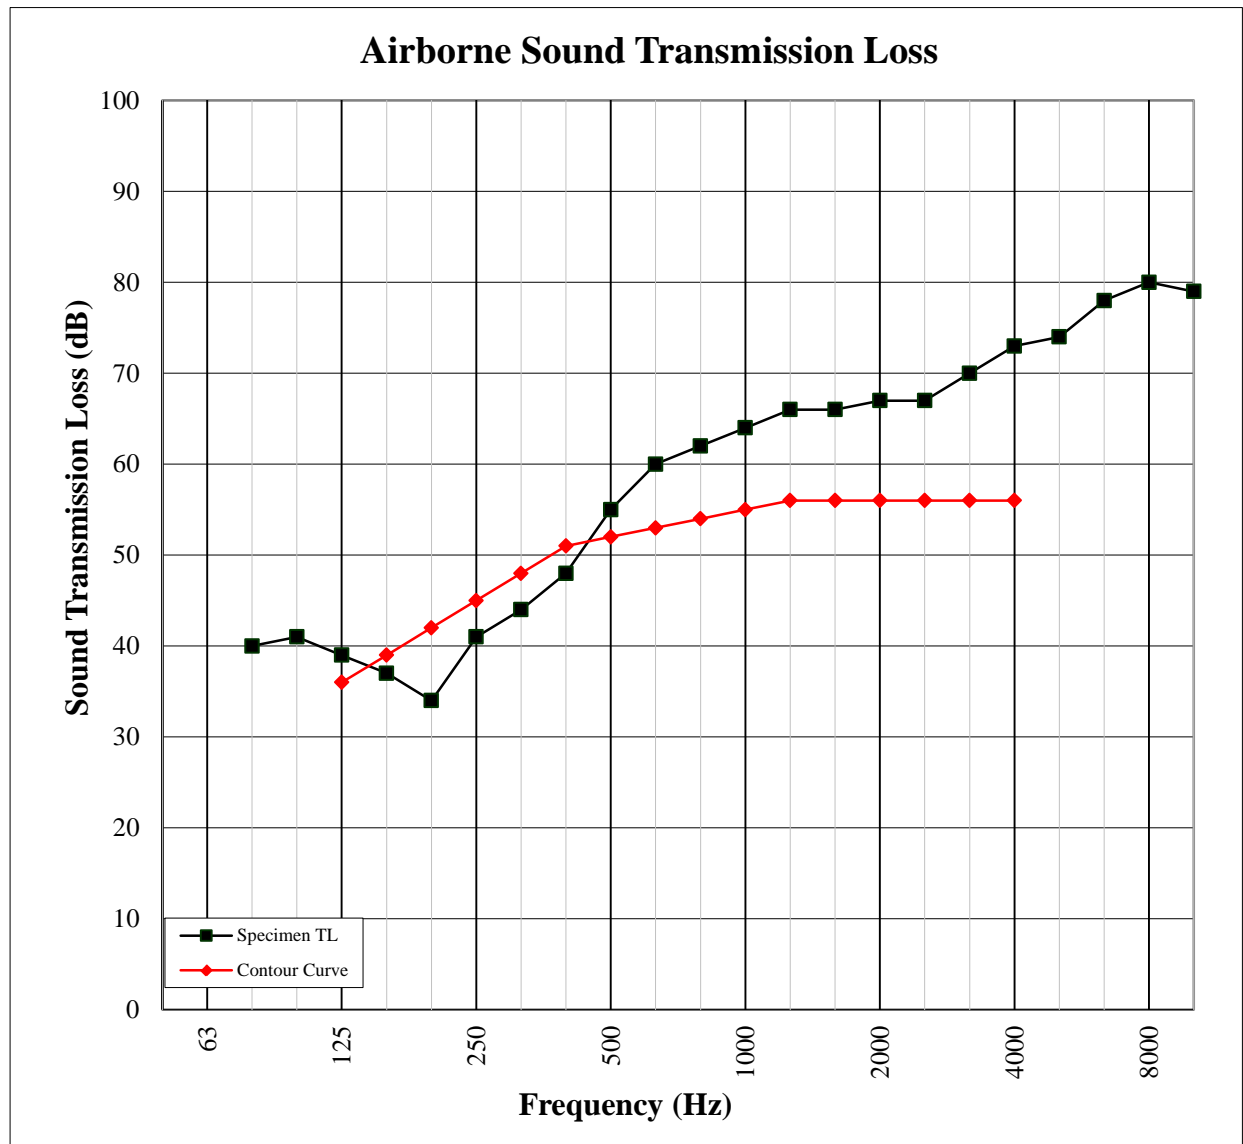
### AIRBORNE SOUND TRANSMISSION LOSS ASTM E 90

**STC Rating**      **52**      (*Sound Transmission Class*)

<b>Test Date</b>	03/25/15
<b>Data File No.</b>	E6534.01
<b>Client</b>	ECORE International
<b>Description</b>	25.4 mm Ecore UltraTile® Rubber Tile Flooring, 152 mm Concrete Slab
<b>Specimen Area</b>	10.98 m <sup>2</sup>
<b>Technician</b>	Jordan Strybos

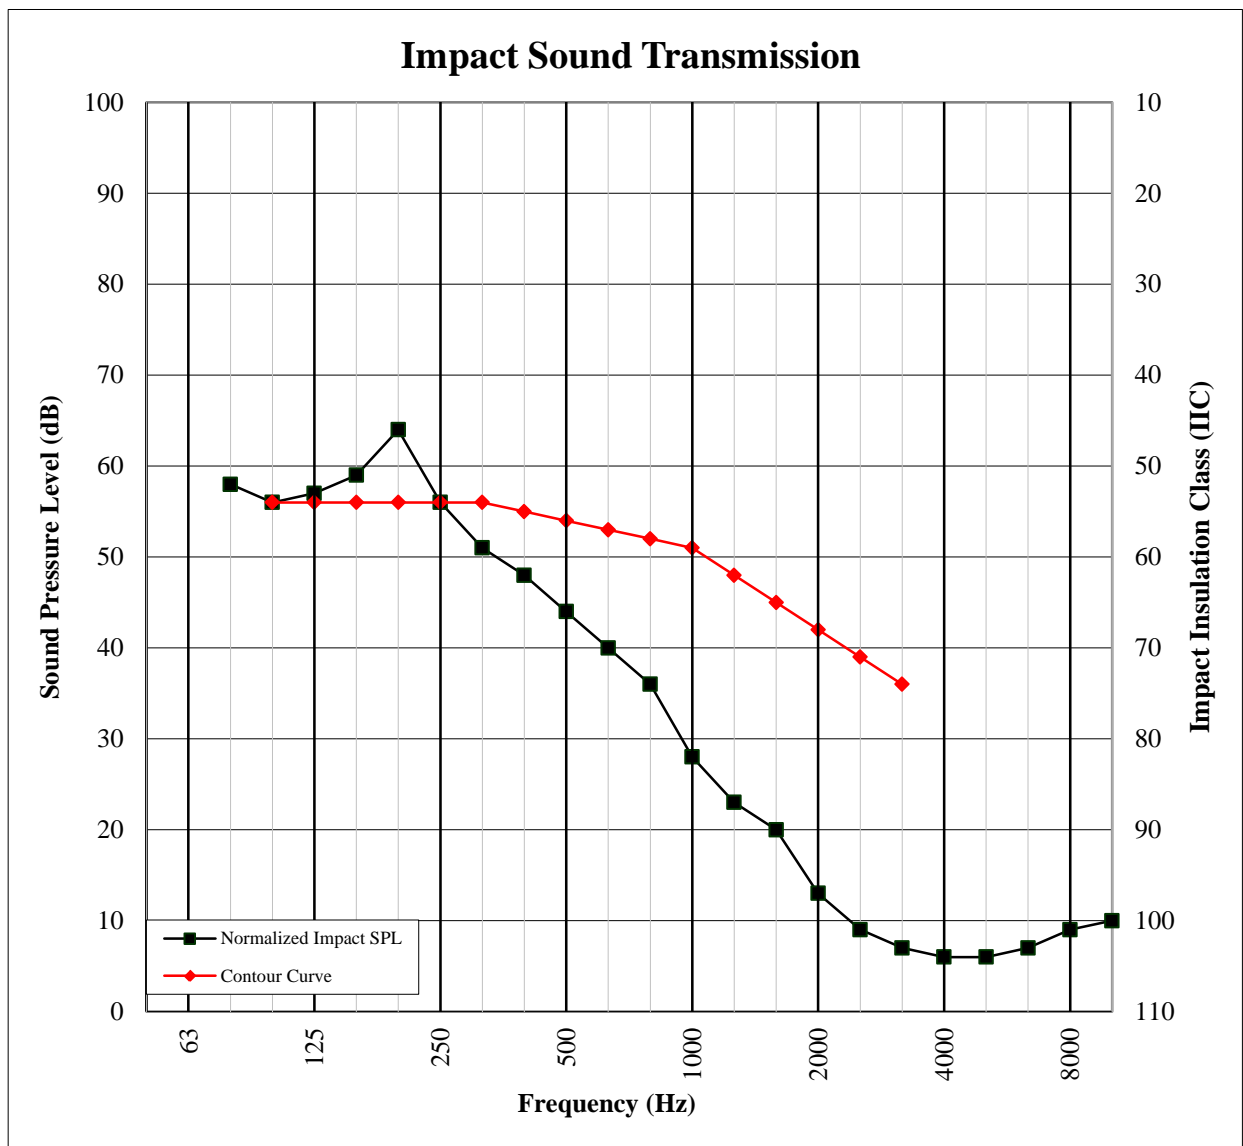
**IMPACT SOUND TRANSMISSION**  
ASTM E 492

**IIC Rating**      **56**      *(Impact Insulation Class)*

<b>Test Date</b>	03/25/15
<b>Data File No.</b>	E6534.01
<b>Client</b>	ECORE International
<b>Description</b>	25.4 mm ECORE UltraTile® Rubber Tile Flooring, 152 mm Concrete Slab
<b>Specimen Area</b>	10.98 m <sup>2</sup>
<b>Technician</b>	Jordan Strybos

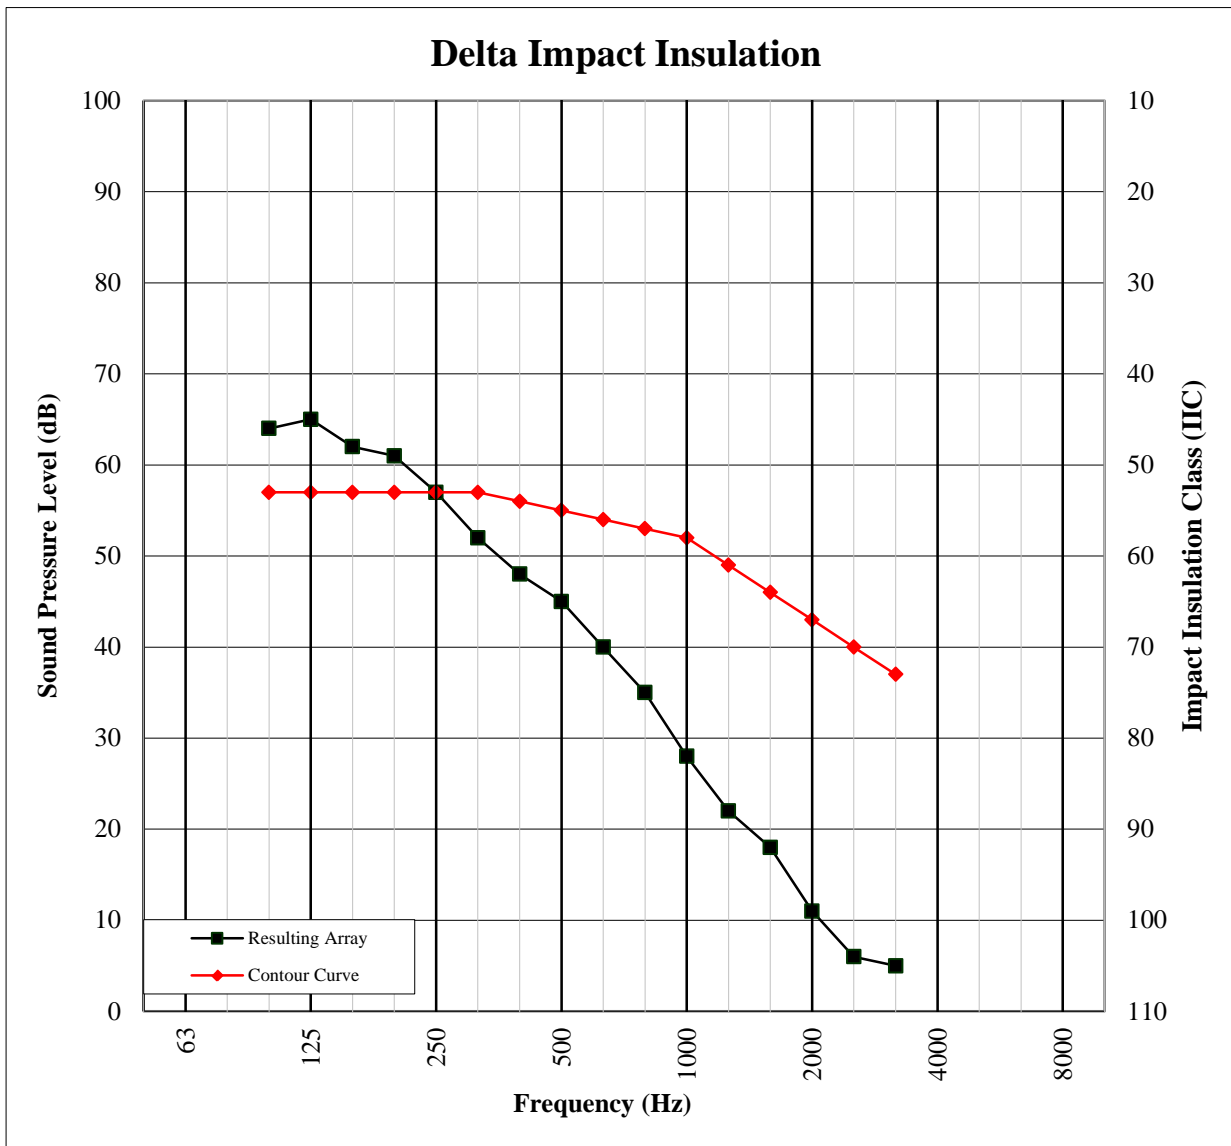
**DELTA IMPACT INSULATION**  
ASTM E 2179

**ΔIIC Rating**     27     *(Delta Impact Insulation Class)*  
**Deficiencies**     24     *(Sum of Deficiencies)*

<b>Test Date</b>	03/25/15
<b>Data File No.</b>	E6534.01
<b>Client</b>	ECORE International
<b>Description</b>	25.4 mm ECORE UltraTile® Rubber Tile Flooring, 152 mm Concrete Slab
<b>Specimen Area</b>	10.98 m <sup>2</sup>
<b>Technician</b>	Jordan Strybos

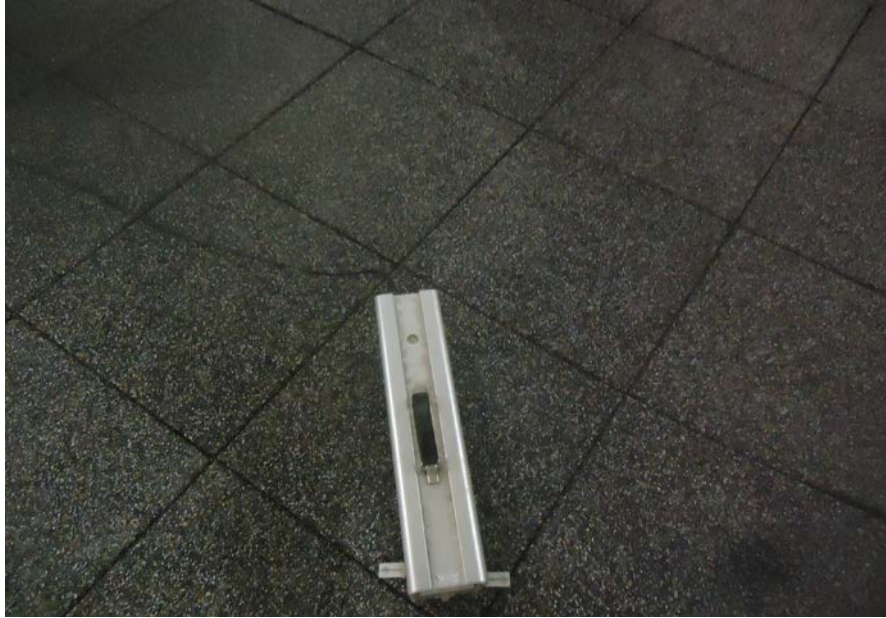
**Close-Up of Test Specimen**

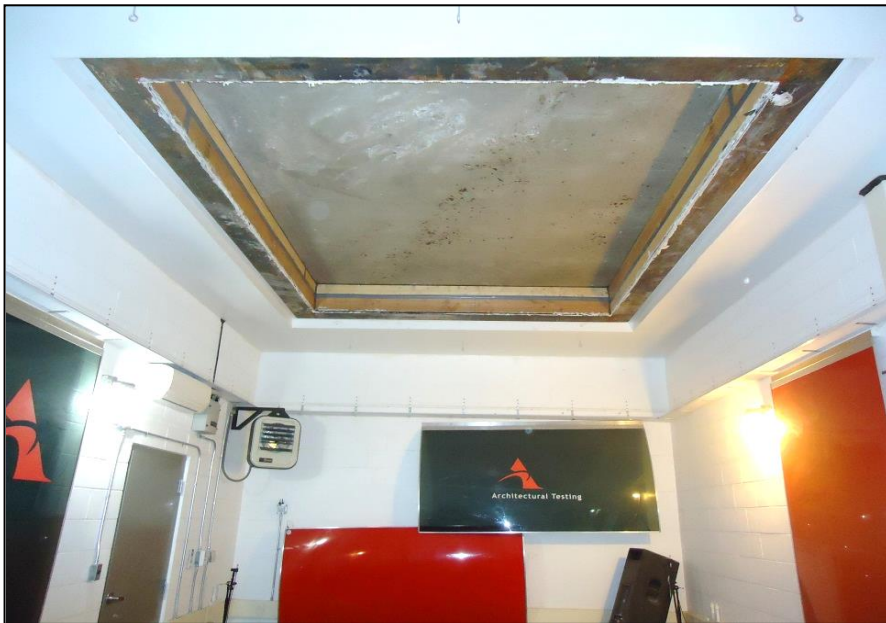
**Receive Room View of Test Specimen Installation**
